BURNETT LAKE DAM
SCOTT COUNTY, MISSOURI
MO 40069

**PHASE 1 INSPECTION REPORT
NATIONAL DAM SAFETY PROGRAM**

MARCH 1981

Name of Dam:	Burnett Lake Dam
State Located:	Missouri
Inventory Number:	MO. 40069
County Located:	Scott
Stream:	Unnamed Tributary to Hindman Creek
Date of Inspection:	3 December 1980

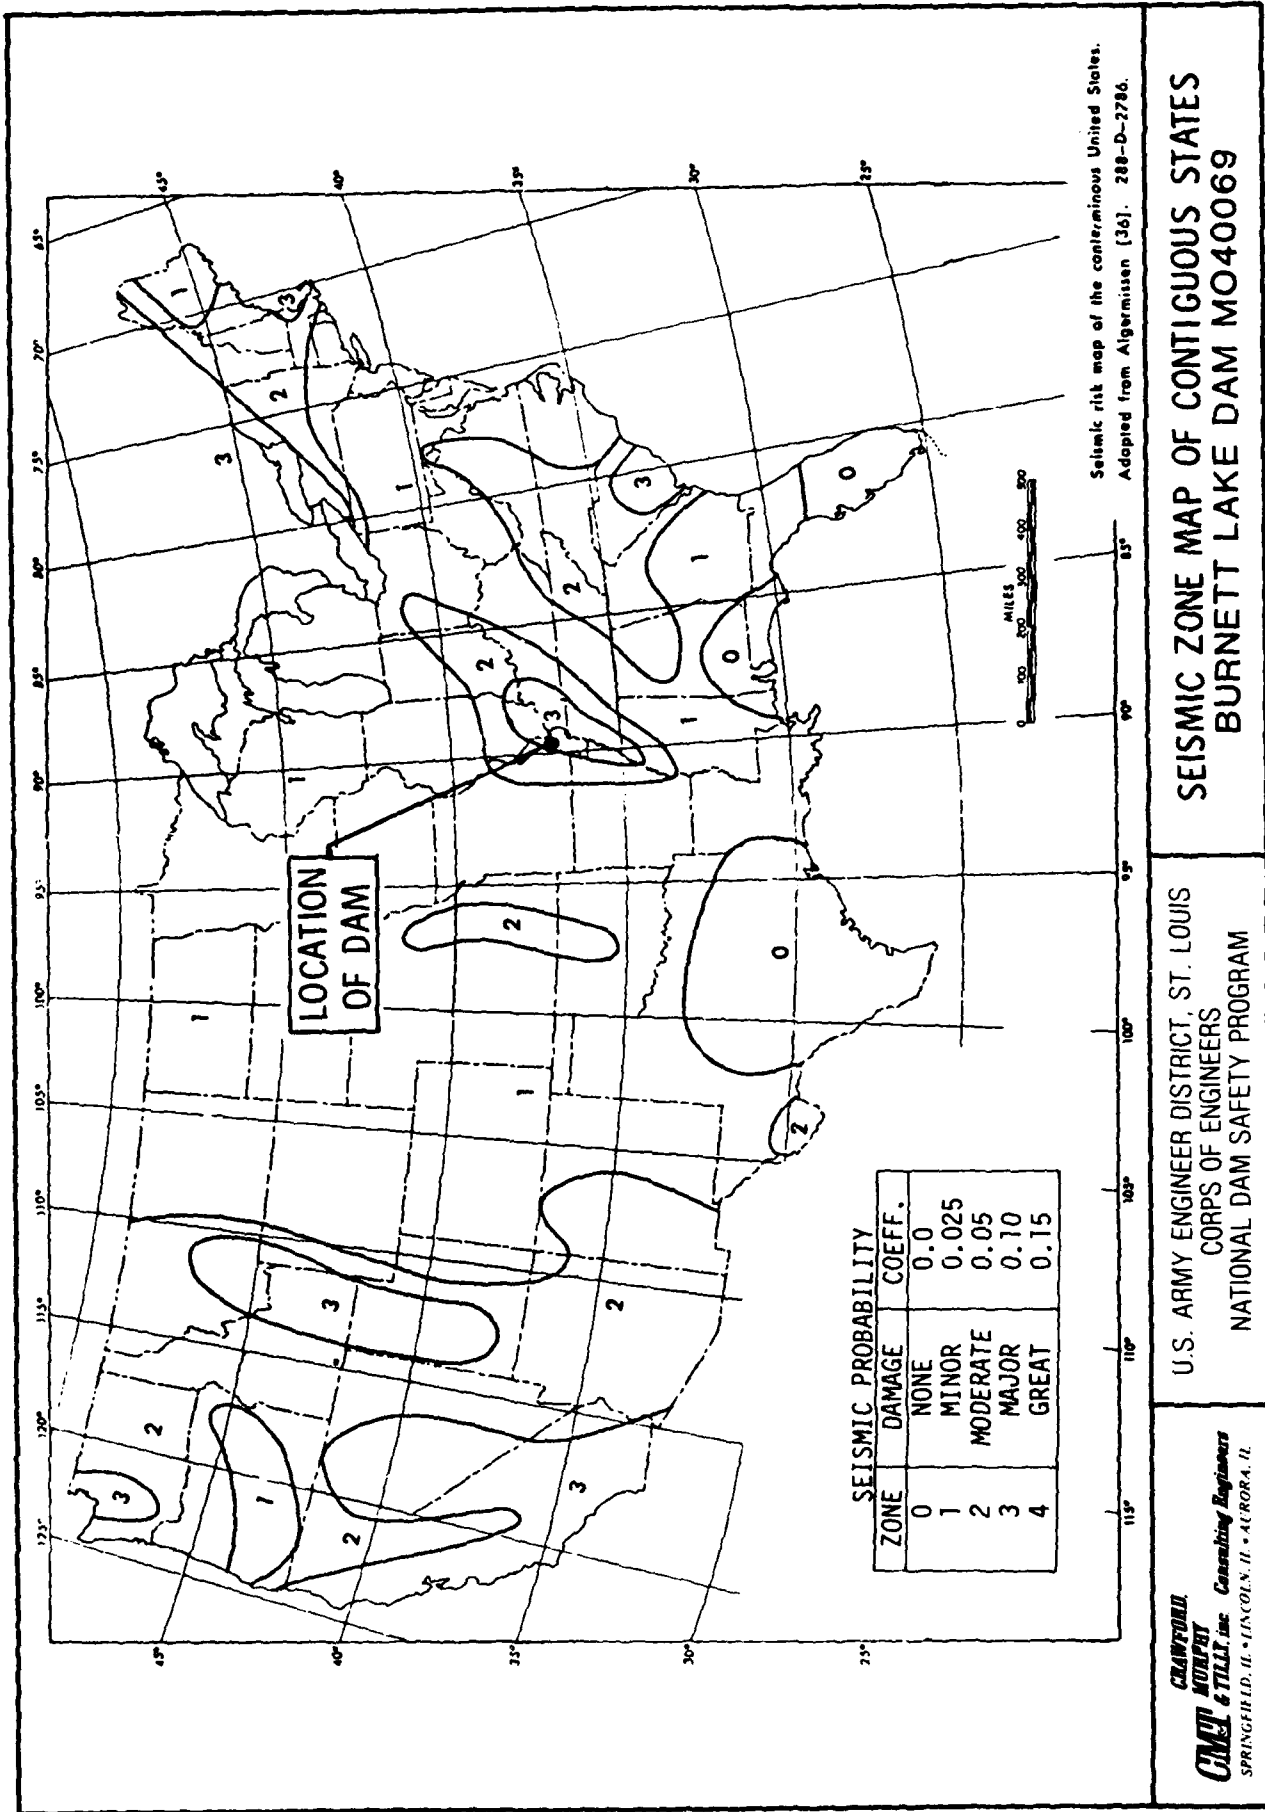
SEISMIC ZONE MAP OF CONTIGUOUS STATES BURNETT LAKE DAM MO40069

This dam is located in Seismic Zone 3, as shown on the Seismic Zone Map on Plate 3 of Appendix A. Zone 3 delineates areas in which major damage would result from the expected seismic activity in this area. An accurate slope stability analysis with seismic loading cannot be made because of the lack of original design data and soil strength parameters. It should be noted that in the event of potential seismic loading, the slopes may become unstable and suffer some damage. The extent of damage would depend upon the intensity and duration of the seismic occurrence.

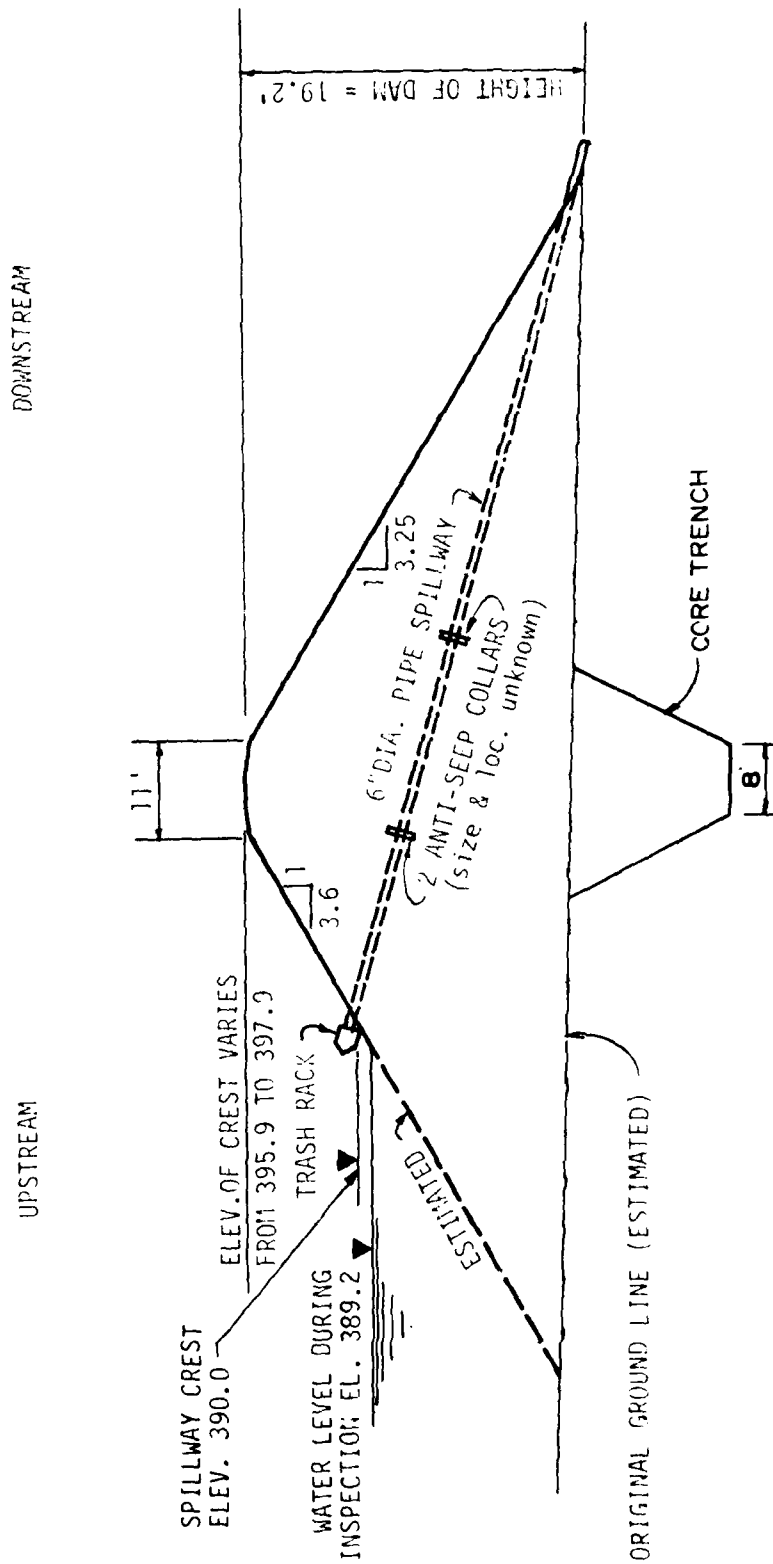
CROSS SECTION OF DAM

The upstream and downstream slopes of the dam are fairly uniform. Although the slope of the downstream face is fairly uniform, the surface has a ridge-like roughness running approximately parallel with the crest as seen in Photograph 4. The crest and upstream face also have this roughness but it is not as pronounced. The crest of the dam is slightly rounded and the break between the crest and the upstream and downstream slopes is not well defined. A typical cross section of the dam can be seen on Plate 5 of Appendix A.
